# PRE-CONSTRUCTION INDOOR ENVIRONMENTAL QUALITY REPORT

### Howard County Public School Systems

October 24, 2017

Soil and Land Use Technology, Inc (SaLUT) was contracted by Howard County Public School System to conduct an Indoor Environmental Quality (IEQ) visual inspection and assessment for suspected mold growth matters, existence or the potential of water intrusion events, and odors at **Mount View Middle School** premises located in 12101 Woodford Drive, Marriottsville, MD 21104. The inspection and assessment was conducted between August 17 and 18, 2017.

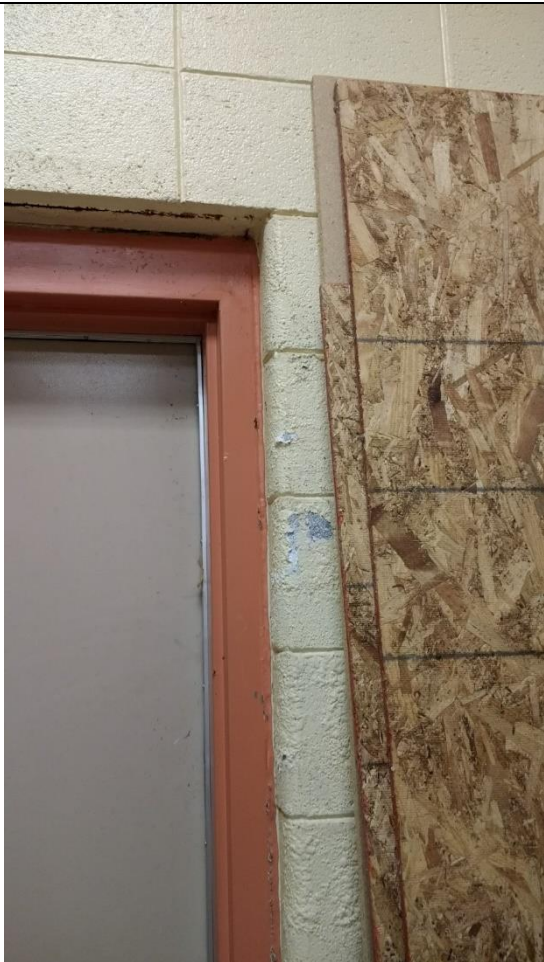
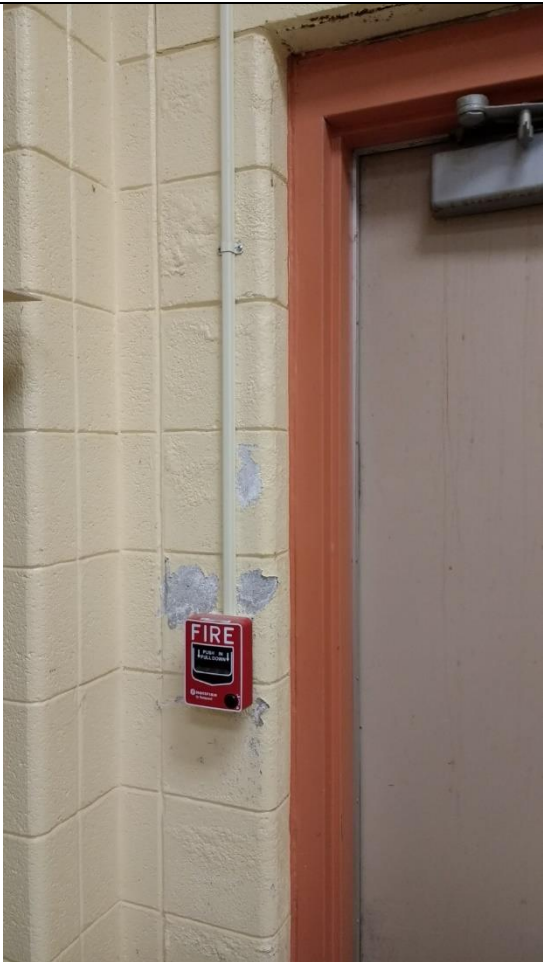
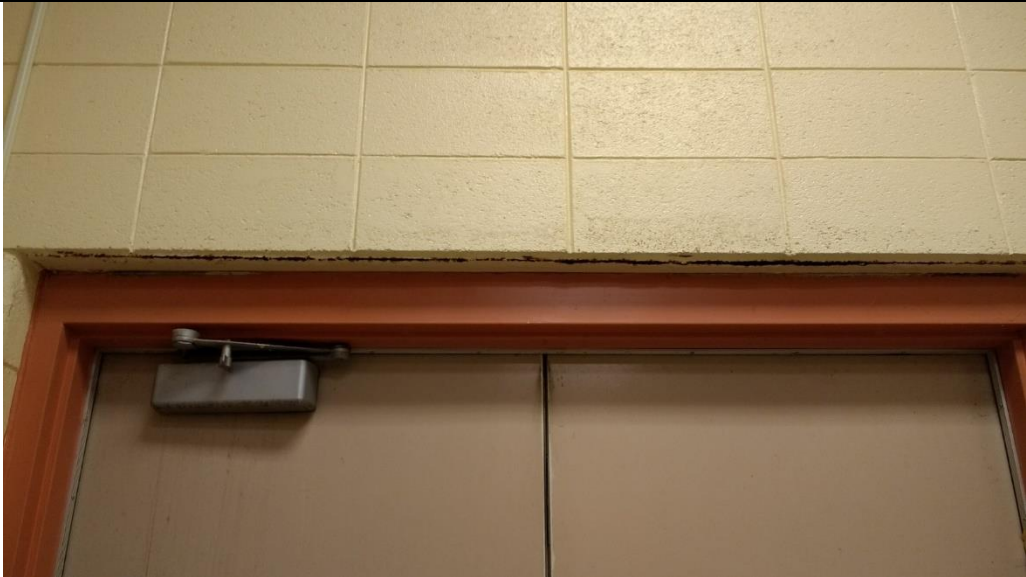
A ceiling tile with stains of dried off water damage due to leakage of water at sanitary drainage pipe joint. The leak appeared to be repaired thus the tile was not damp at the time of the inspection. The ceiling tile can be simply replaced as a remediation method since there are no signs of current water leaks above the tile. The metal frame of the door shows signs corrosion and the wall paint around the frame is peeling off. No signs of mold as of the day of inspection.

Photo 1: Supply Storage

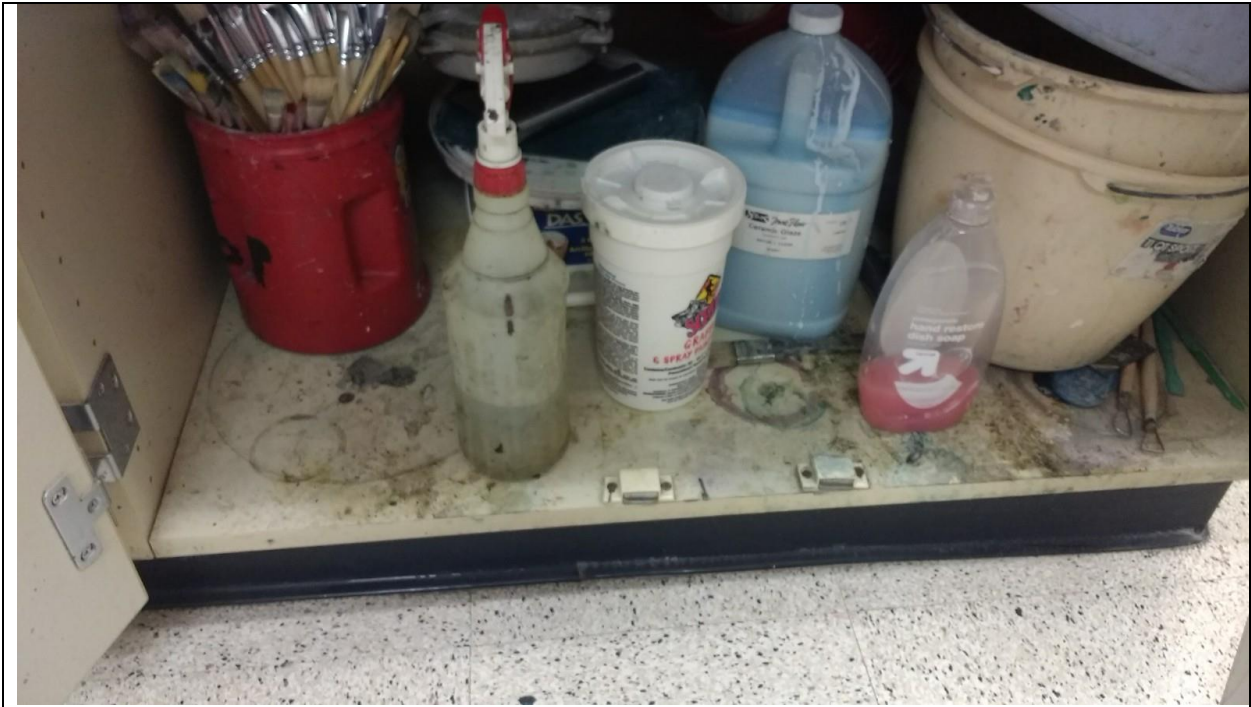
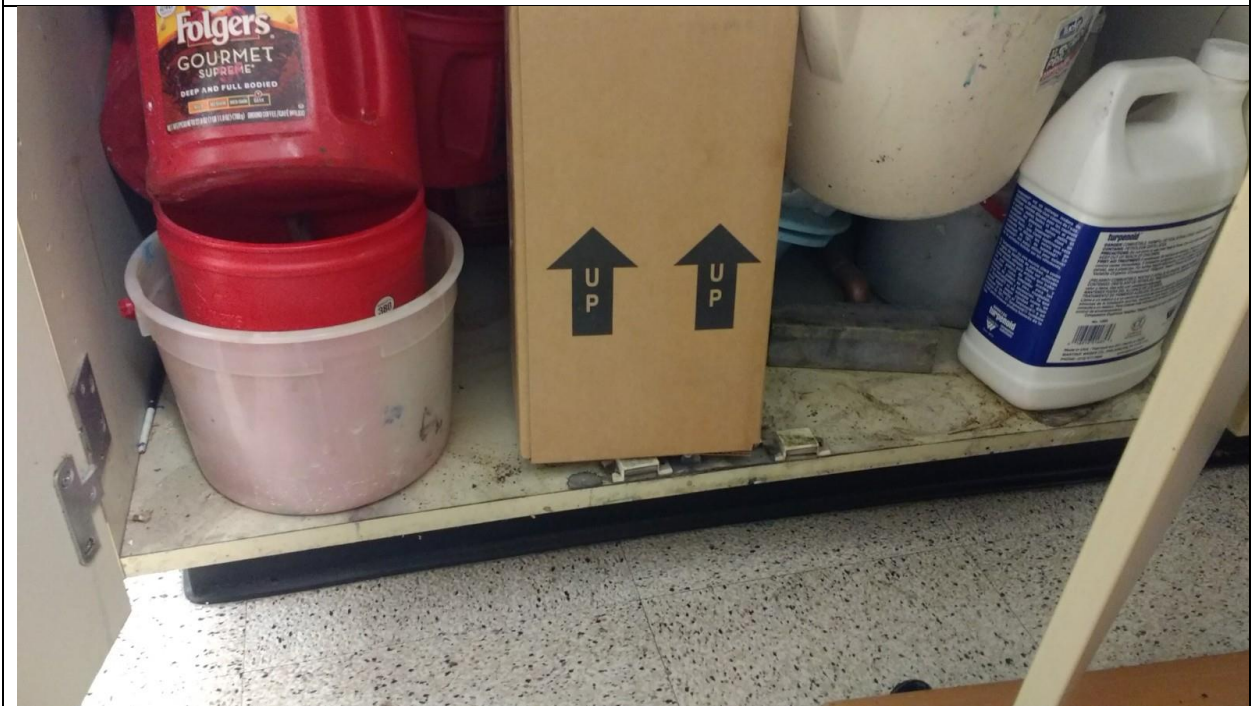
Water damage and stains on the plywood baseboard at the sink due to paint supply storage underneath.

Photo 4: Sink baseboard – Art Room

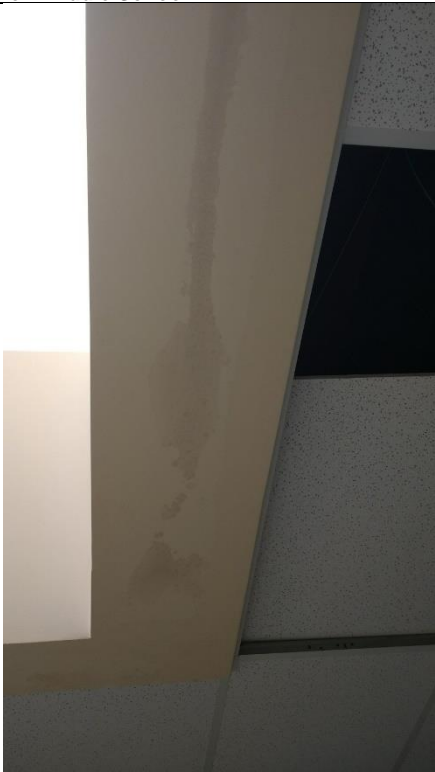
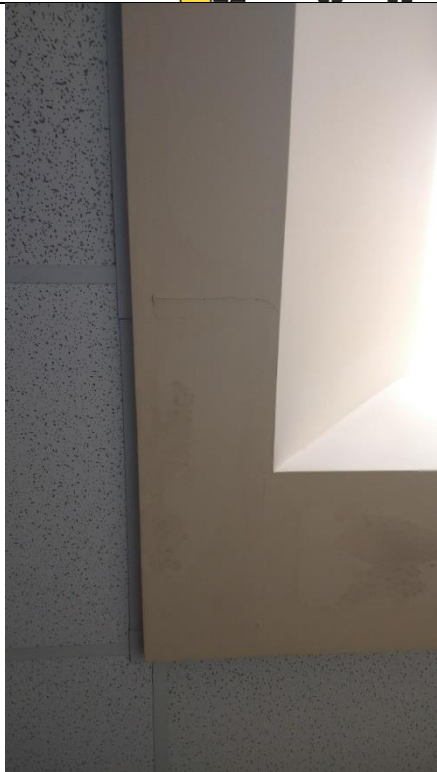
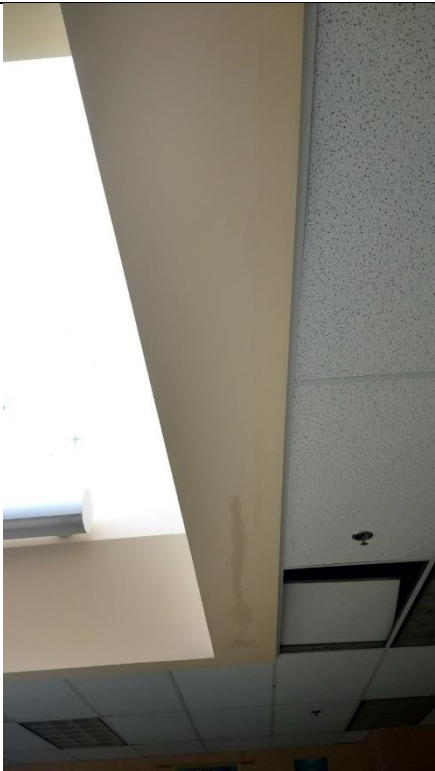
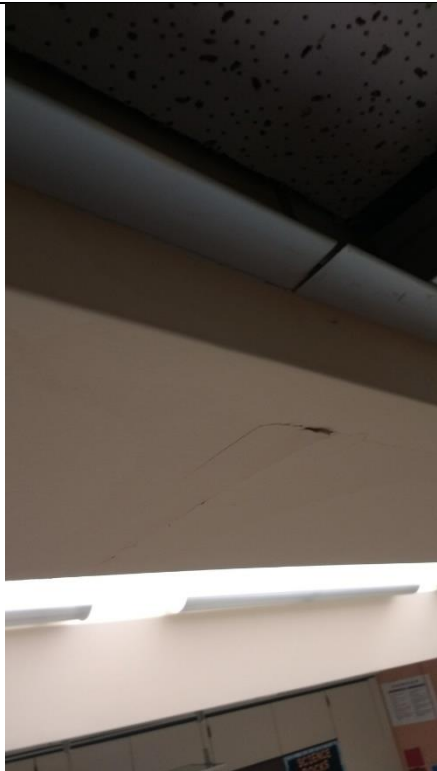
Water damage and stains around the edge of the atrium. No signs of visible mold growth. The inspectors suspect it was leaking through the roof since there were no visible pipes running above the atrium edge.

Photo 6: Science 2 - Skylight Edge

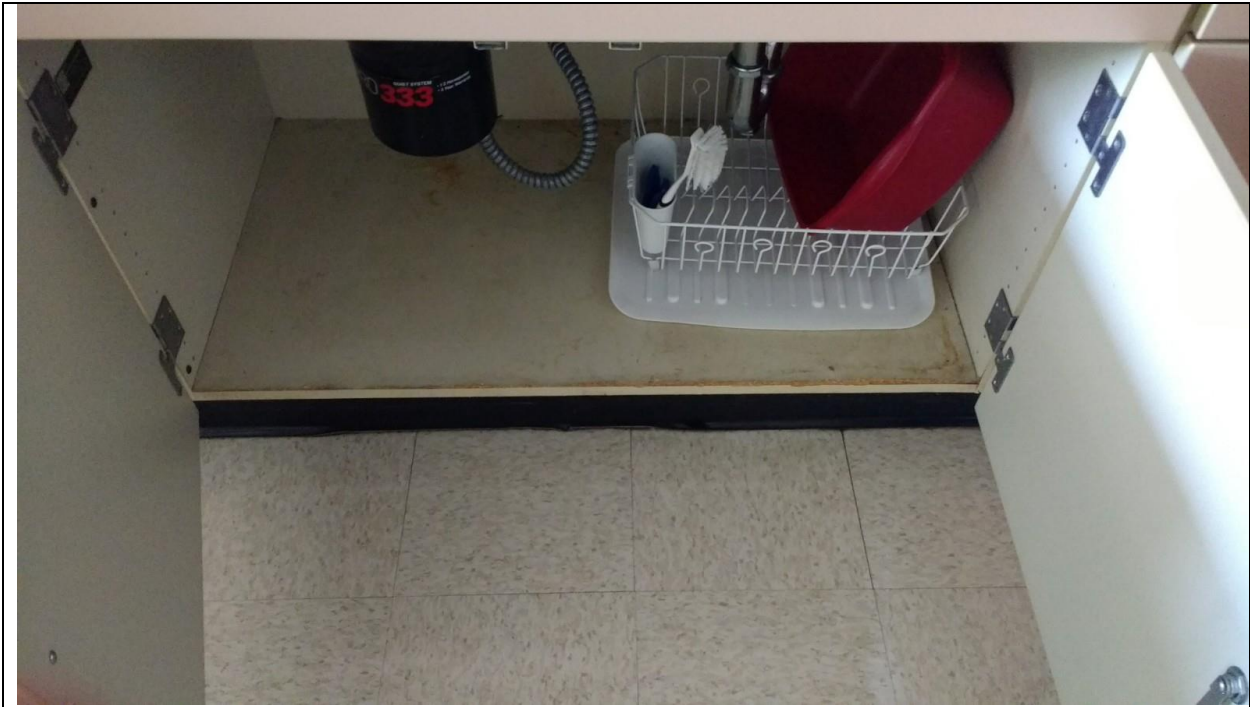
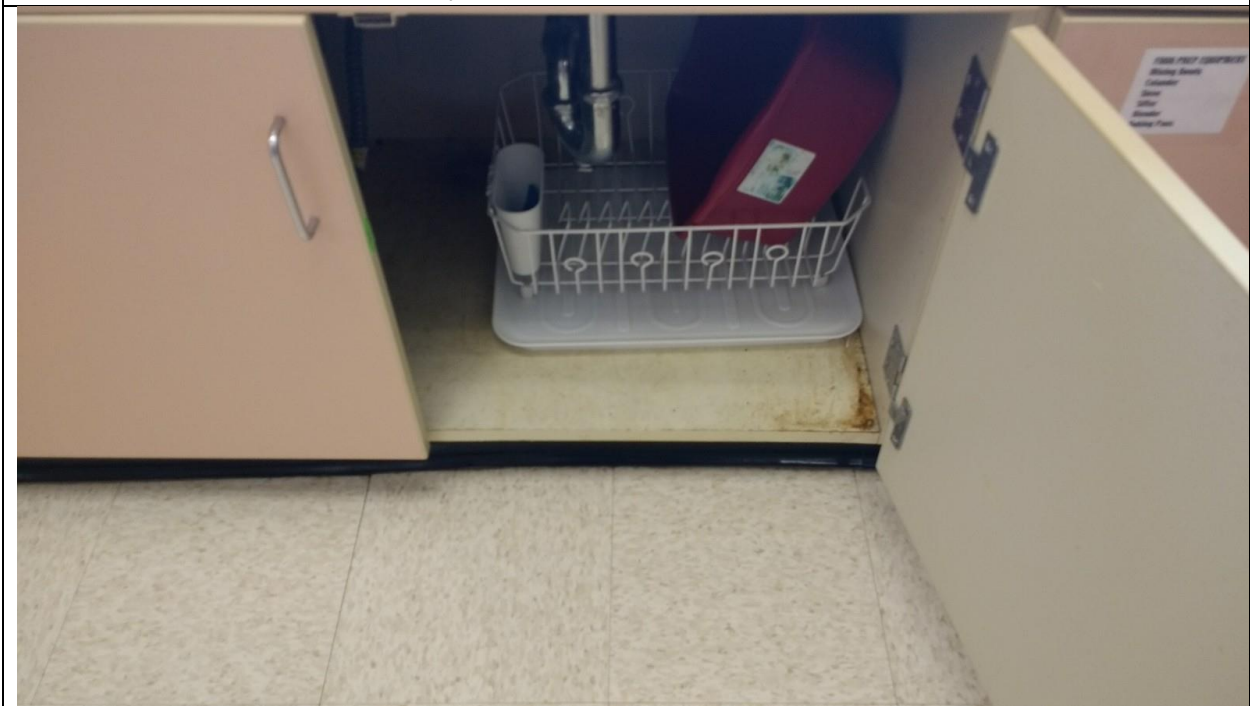
Water damage on the plywood baseboard of sinks 1, 2, 3 and 4. The cause of the damage was the dish drain pan stored under the sink which drains water from the dishes on to the floorboard. The floor board could be replaced with a non-porous material like metal or plastic as means of remediation.

Photo 10: Sink Baseboard – Family and Consumer Sciences Room
